APPENDIX TWO

A Royal 'Haagse klok' "Severyn Oosterwijck Haghe met privilege"

Reviewed by Keith Piggott

Recommendation for Conservation

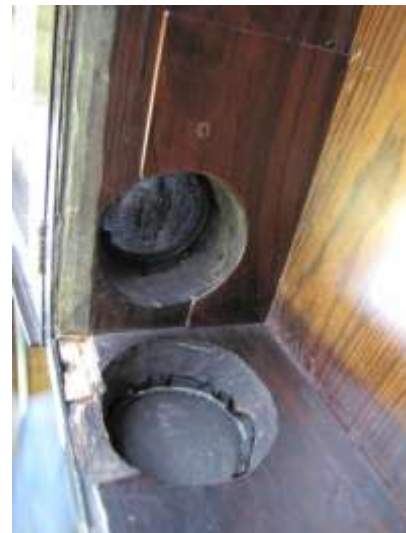
Kingwood slips now cover the chopped-out sides

Leave the upper peg holes, as probable evidence for a crest or pediment being added then removed. Make good solid show-wood (Kingwood) backboard; close the two drilled holes; re-glue the split. Enclose the two inner chopped-out sides of the box with matching Kingwood veneers. Replace the damaged veneers fronting the dial-pins; repair the cracked and lifting ebony veneer around the lock mortice. Remove the later steady strips, nailed beneath the box, to end its "**Mantle Clock**" status for good.

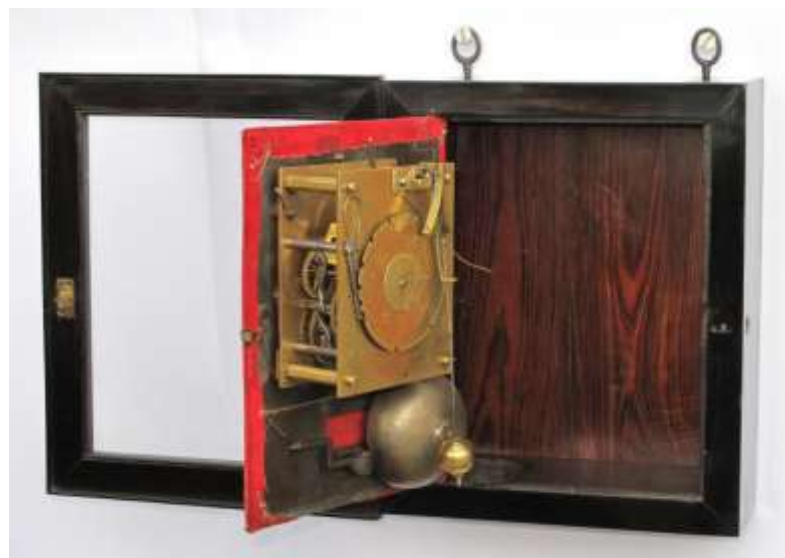
Kingwood backboard holes filled, ebony veneers repaired
